ñautel	Solutions Support	Why Nautel	We're Listening News & Events Re	esources Contact	NUG Sign-in Agent Sign-in
Technical Resources	Contact Support	Training	Policies	Nautel eStore	NUG
Tips 'n Tricks: 25-01-2011

It's good to be well grounded...

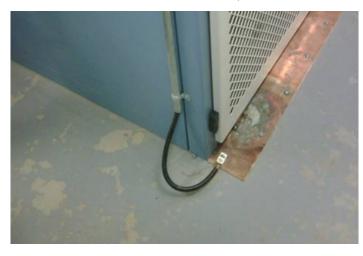
Further sleuthing showed a bit of a ground loop, in that the conduit carrying the electrical ground from the service panel to the transmitter ground strap was bolted to the transmitter chassis, creating a ground loop (the ground stud on the transmitter is insulated from chassis to provide a single point ground connection at the coaxial connector – the stud is connected to the coax connector via 2 AWG wires).

Adding a ground rod to the tower base, removing the conduit from the transmitter and connecting a strap from the surge protector to a properly driven ground rod at the AC entrance, as well as connecting the tower ground rod and AC ground rod with strap around the outside of the building made all the difference in the world. Failures have decreased from one every couple of weeks during storm season to zero since July 2009.

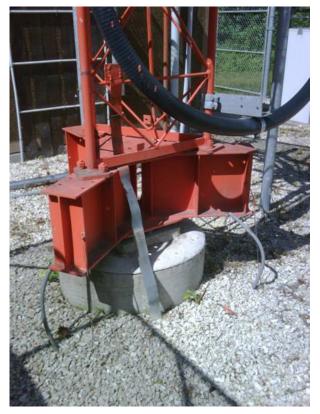
Then, it was out to the antenna, where we were gratified to see a nice heavy strap coming off the tower.

Unfortunately, the one thing we didn't see anywhere between the tower and the transmitter, after checking the strap, was a ground rod... effectively, the tower was connected directly to the transmitter. At that point, we decided to further investigate the AC entrance ground, which was the only path to ground for lighting, besides through the transmitter power supplies. We found this...
